# Understanding the mechanism of fast corrosion initiation caused by KCl on waterwalls and superheated materials in waste and bio-fired power plants

In this work we investigated the initial oxidation of a low-alloyed steel (Fe–2.25Cr–1Mo) in the presence of small amounts of KCl(s) using ESEM in-situ exposure and analysis at 400 °C<sup>1</sup>. We used XRD, SEM/EDX and FIB for characterizing the corrosion products and microstructure. The results show the role of KCl in general corrosion of the low alloyed steels even in small amounts. We concluded that the KCl's initial distribution has an important effect on the corrosion behavior of the alloy. Equilibrium calculations using Factsage software show formation of a KCl/FeCl<sub>2</sub> liquid phase film on large parts of the oxide surface in the presence of KCl. We propose that Cl increases the oxidation rate by affecting the grain boundaries in oxide phase and decreases the oxide scale adhesion.

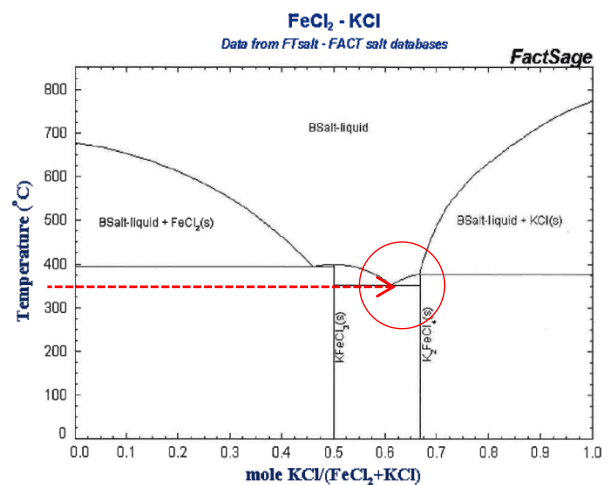
The sudden onset of rapid hematite growth at 355°C caused by FeCl<sub>2</sub>/KCl eutectic melt on the surface.
